Langan Park - Baseball Complex

City of Mobile Parks and Recreation

Assessment Date: 3/20/2017
 Accessibility Assessment Conditions Report

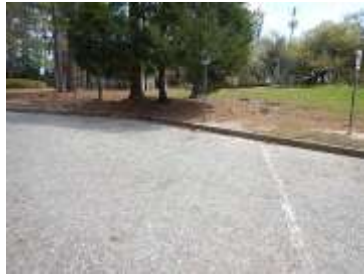
West - Parking

There are 63 standard parking spaces in the west entrance parking lot. One designated accessible parking space is located in the lot, another designated accessible parking space is located in the circle drive adjacent to the restroom building. Both designated accessible parking spaces lack pavement markings and access aisles. The accessible parking space at the restroom building has broken, uneven asphalt pavement.

If the accessible parking space at the circle drive adjacent to the restroom building is to remain, grade and repave the existing space and access aisle not to exceed 2.08% in all directions. For this size parking lot, at least 3 accessible parking spaces are required. Stripe for a minimum of one van accessible parking space (132 inches wide), 2 car accessible parking space (96 inches wide) and access aisles (60 inches wide). Alternatively, all accessible parking spaces could be striped as universal with 96 inch width for each accessible space and 96 inch width for each access aisle. Install signs designating the accessible parking spaces including the International Symbol of Accessibility. Signs identifying van parking spaces shall contain the designation "van accessible." Signs shall be 60 inches minimum above the finish floor or ground surface measured to the bottom of the sign.

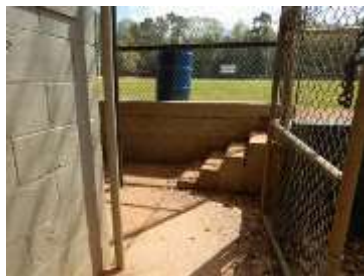
Ball Field A - Right Field Team Seating

The right field team dugout lacks an accessible route to the playing field. There are 5 steps from the team seating area in the dugout onto the playing field.

Remove the existing steps and install an accessible route connecting from the main circulation path to the team seating area and onto the playing field.

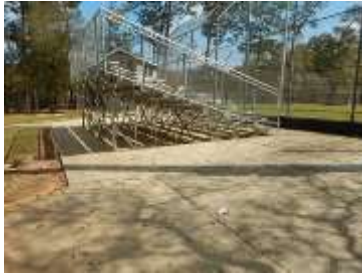
Ball Field A

The concrete pad for the bleacher seating areas at ball field lacks clear floor space for both wheelchair accessible seating and companion seating. The 2 bleachers seat an estimated 100 spectators. The frame at the rear of the bleachers protrudes into the path of travel more than 4 inches at 69 inches above the ground surface creating a hazard for people with visual impairments.

Widen each concrete pad to provide a minimum of 2 wheelchair accessible seating locations at each bleacher. Each wheelchair seating location should be a minimum 36 inches wide by 48-60 inches deep depending on the side or forward approach. The wheelchair seating spaces shall be connected to the accessible route, but shall not overlap the circulation path. When the bleachers are replaced, select a design that accommodates wheelchair accessible seating with adjacent shoulder to shoulder companion seating. Install a cane detectable treatment along the path at the rear of the bleachers to eliminate the protruding hazard of the bleacher frame.

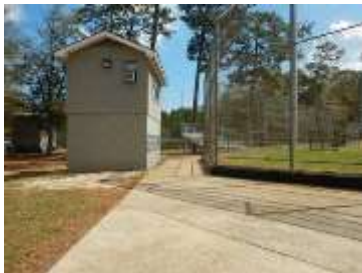
Ball Field A

There is no vertical access to the 2-story press box/scorer building.

Implement a procedure to immediately relocate the functions for the upper floor of the press box/scorer building to the ground floor upon request of an individual with a disability who may be an employee, volunteer, coach, official, visitor or other. This may require the acquisition or installation of new technology to remotely operate the score board or use the public address (PA) system from the ground floor.

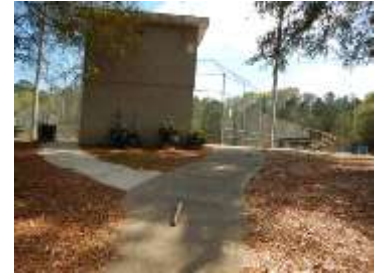
<p><u>Ball Field F</u></p>	<p>Modify existing pathway</p> <p>There is up to a 12.6% running slope on the concrete path to Ball Field F.</p> <p>Remove the 50 ft section of concrete path, grade and install accessible route not to exceed 5% running slope with maximum 2.08% cross slope. It may be necessary to reroute the accessible route due to the change in elevation for the existing terrain.</p> <p>Reference: ADA 402 Photo: LanganBaseball-044 Record #: 189</p>	<p>Priority 1 - Critical</p>	<p>\$18,000</p>

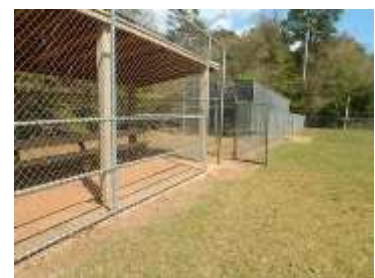
<p><u>Ball Field F</u></p>	<p>Provide accessible route to team seating areas</p> <p>There is no accessible route connecting the main circulation path to the team seating areas. Players, coaches and officials must enter the field to get to the dugouts. The left field team dugout lacks an accessible route to the playing field. There is a 6 inch step from the team seating area in the dugout onto the playing field.</p> <p>Extend the main concrete path for an estimated 50 ft to each team dugout and create a direct accessible point of entrance to each team area that does not require people to go through the sports field. Eliminate the 6 inch change in level from the team seating area to the sports field.</p> <p>Reference: ADA 206, 221.2.1.4, 402 Photo: LanganBaseball-042 Record #: 191</p>	<p>Priority 1 - Critical</p>	<p>\$17,500</p>

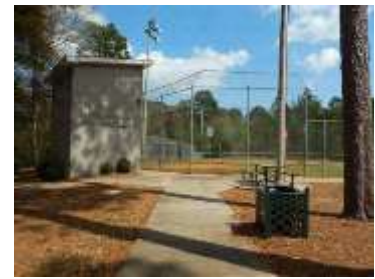
<p><u>Ball Field F</u></p>	<p>Provide accessible route to press box/scorer building</p> <p>There is no vertical access to the 2-story press box/scorer building.</p> <p>Implement a procedure to immediately relocate the functions for the upper floor of the press box/scorer building to the ground floor upon request of an individual with a disability who may be an employee, volunteer, coach, official, visitor or other. This may require the acquisition or installation of new technology to remotely operate the score board or use the public address (PA) system from the ground floor.</p> <p>Reference: ADA 206.2.7 Photo: LanganBaseball-034 Record #: 192</p>	<p>Priority 1 - Critical</p>

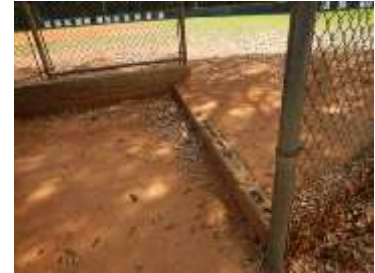
<p><u>Ball Field C - Right Field</u></p>	<p>Provide accessible route to team seating areas</p>	<p>Priority 1 - Critical</p>	<p>\$7,000</p>
<p>There is no accessible route to the right field team seating areas at the ball field. Players, coaches and officials must enter the field to get to the dugouts. There is a 6 inch step from the team seating area in the dugout onto the playing field.</p>				
<p>Extend the main concrete path for an estimated 20 ft to the right field team dugout and create a direct accessible point of entrance to the team area that does not require people to go through the sports field. Eliminate the 6 inch change in level from the team seating area to the sports field.</p>				
<p>Reference: ADA 206, 221.2.1.4, 402 Photo: LanganBaseball-065 Record #: 196</p>

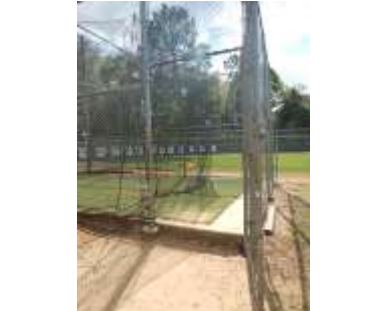
<p><u>Ball Field C - Batting Cage at Left Field</u></p>	<p>Provide accessible route to sports field/court</p>	<p>Priority 1 - Critical</p>	<p>\$17,500</p>

<p>There is no accessible route to the batting cage and there is up to an 8 inch step to the practice station.</p>				
<p>Extend the concrete path an estimated 50 ft to create an accessible route to the batting cage. The surface should be level at the point of entrance into the batting cage and thereby eliminate the 8 inch step onto the practice surface.</p>				
<p>Reference: ADA 206, 221.2.1.4, 402 Photo: LanganBaseball-062 Record #: 197</p>

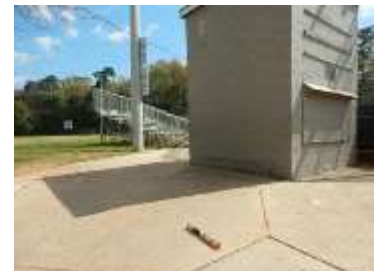
<p><u>Ball Field C</u></p>	<p>Provide accessible route to press box/scorer building</p>	<p>Priority 1 - Critical</p>	
<p>There is no vertical access to the 2-story press box/scorer building.</p>				
<p>Implement a procedure to immediately relocate the functions for the upper floor of the press box/scorer building to the ground floor upon request of an individual with a disability who may be an employee, volunteer, coach, official, visitor or other. This may require the acquisition or installation of new technology to remotely operate the score board or use the public address (PA) system from the ground floor.</p>

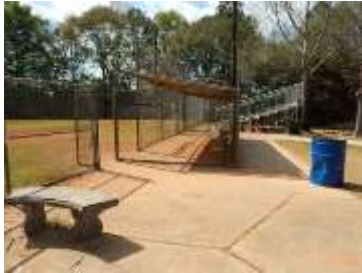
Ball Field D

There is no accessible point of entry to the team seating areas at the ball field. Players, coaches and officials must enter the field to get to the dugouts where there is up to a 1 inch change in level from the ball field surface to the concrete pads at the dugouts.

Create an accessible point of entry to each of the 2 team seating areas with a minimum 32 inch (preferably 36 inch) wide opening and connected to the accessible route of the existing concrete path.

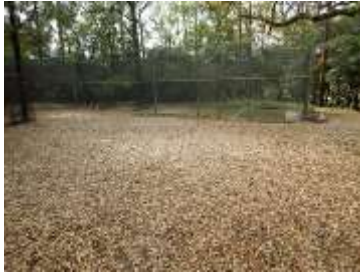
<p><u>Ball Field B - Batting Cage</u> Provide accessible route to sports field/court</p> <p>There is no accessible route to the batting cage.</p> <p>Extend the concrete path an estimated 30 ft to create an accessible route to the batting cage.</p> <p>Reference: ADA 206, 221.2.1.4, 402 Photo: LanganBaseball-097 Record #: 207</p>	<p>Priority 1 - Critical</p>	<p>\$10,500</p>

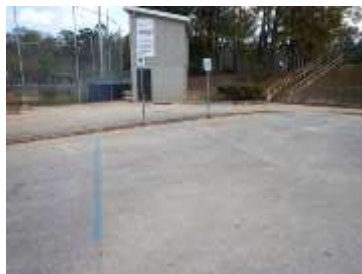
East - Parking

There are 148 standard parking spaces and 4 designated accessible parking spaces. None of the designated accessible parking spaces have the required compliant access aisles.

For this size parking lot, a minimum of 5 accessible parking spaces are required. Stripe for a minimum of one van accessible parking space (132 inches wide), 4 car accessible parking space (96 inches wide) and access aisles (60 inches wide). Alternatively, all accessible parking spaces could be striped as universal with 96 inch width for each accessible space and 96 inch width for each access aisle. Install signs designating the accessible parking spaces including the International Symbol of Accessibility. Signs identifying van parking spaces shall contain the designation "van accessible." Signs shall be 60 inches minimum above the finish floor or ground surface measured to the bottom of the sign.

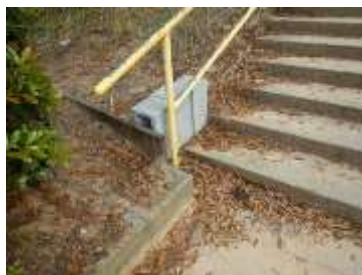
Stairs to Ball Field E and East Parking

The bottom landing of the stairs is obstructed by a planter edging that projects into the clear width of the stairs. Use of the handrail would lead people with visual and mobility impairments into the planter resulting in a safety hazard.

Remove the planter edging and trim the bushes to provide a clear, unobstructed accessible route the full width of the stairs.

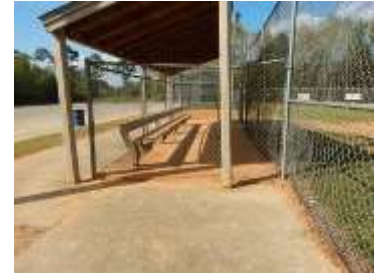
<p><u>Ball Field E</u></p>	<p>Provide accessible route to team seating areas</p> <p>There is no accessible route to the team seating areas at the ball field. Players, coaches and officials must enter the field to get to the dugouts.</p> <p>Create an accessible point of entry to each of the 2 team seating areas with a minimum 32 inch (preferably 36 inch) wide opening and connected to the accessible route of the existing concrete path.</p> <p>Reference: ADA 206, 221.2.1.4, 402 Photo: LanganBaseball-129 Record #: 215</p>	<p>Priority 1 - Critical</p>	<p>\$3,000</p>

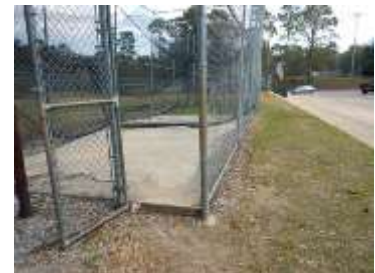
<p><u>Ball Field E - Batting Cage</u></p>	<p>Provide accessible route to sports field/court</p> <p>There is no accessible route to the batting cage in left field.</p> <p>Extend the concrete path an estimated 15 ft to create an accessible route into the batting cage and level with the sport surface.</p> <p>Reference: ADA 206, 221.2.1.4, 402 Photo: LanganBaseball-131 Record #: 216</p>	<p>Priority 1 - Critical</p>	<p>\$5,200</p>

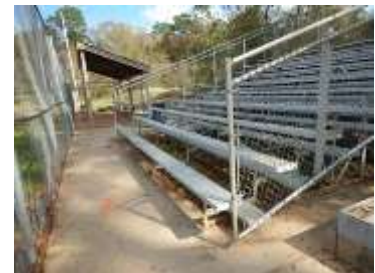
<p><u>Ball Field E - Right Field Bleacher Seating</u></p>	<p>Provide integrated accessible seating at spectator viewing area</p> <p>The concrete pad for the bleacher seating area along right field lacks clear floor space for both wheelchair accessible seating and companion seating. The bleachers seat an estimated 50-100 spectators.</p> <p>Widen each concrete pad to provide a minimum of 2 wheelchair accessible seating locations at each bleacher. Each wheelchair seating location should be a minimum 36 inches wide by 48-60 inches deep depending on the side or forward approach. The wheelchair seating spaces shall be connected to the accessible route, but shall not overlap the circulation path. When the bleachers are replaced, select a design that accommodates wheelchair accessible seating with adjacent shoulder to shoulder companion seating.</p> <p>Reference: ADA 221, 802 Photo: LanganBaseball-125 Record #: 217</p>	<p>Priority 1 - Critical</p>	<p>\$7,500</p>

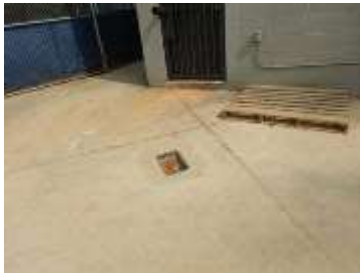
Ball Field E

On the accessible route from the parking to the scorer building, the water meter cover is missing. This excessive opening in the surface can be a tripping hazard.

Replace the water meter cover to eliminate the opening in the accessible surface.

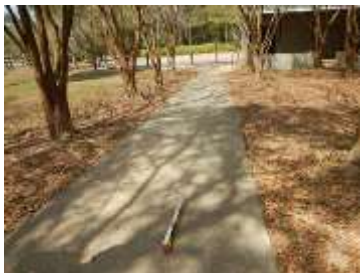
West - Path from Parking to Ball Field A

The path from the accessible parking space, restroom building and Ball Field A has a running slope up to 11.3% for 35 ft.

Remove the existing section of path, grade and resurface not to exceed a running slope of 5%.

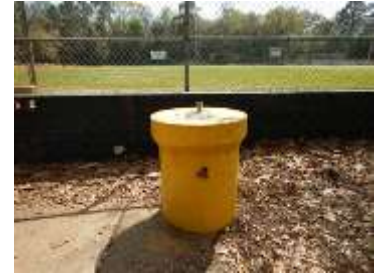
<p><u>Ball Field A</u></p>	<p>Add/replace existing drinking fountain with high-low unit</p> <p>There is a Mobile drinking fountain located at each team dugout. The drinking fountain is not wheelchair accessible.</p> <p>Replace the drinking fountains with new high-low combination units in order to provide both a wheelchair accessible height fountain and a standing height fountain. Install on an accessible route positioned with clear floor space set back from the accessible route so not to obstruct pedestrian traffic.</p> <p>Reference: ADA 211, 602 Photo: LanganBaseball-017 Record #: 185</p>	<p>Priority 2 - Serious</p>	<p>\$5,000</p>

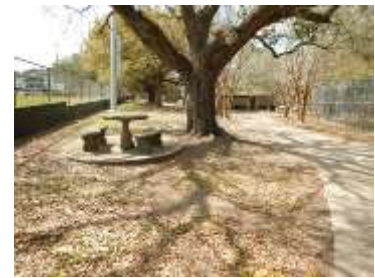
<p><u>Open Picnic Areas</u></p>	<p>Provide picnic units with mobility features</p> <p>There are up to 13 picnic tables dispersed along routes to the ball fields. None of the tables are designed to be accessible with wheelchair seating spaces. More than half of the tables are not located on an accessible route.</p> <p>At least 20 percent, but not less than two, of the picnic units shall provide mobility features including accessible outdoor constructed features, location on an outdoor recreation access route, wheelchair seating, a minimum 36 inch clear floor space around usable sides and operating parts within the reach range. It is recommended that at least one accessible picnic table is installed in the dining area for each concession building</p> <p>Reference: ABAS-Outdoor F245.2, 1011 Photo: LanganBaseball-021 Record #: 188</p>	<p>Priority 2 - Serious</p>	<p>\$5,000</p>

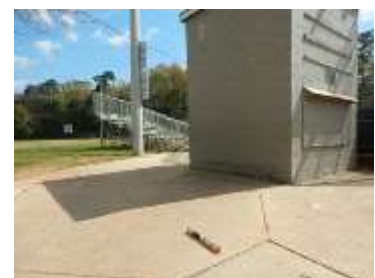
<p><u>Ball Field C - Right Field Bleachers</u></p>	<p>Modify existing pathway</p> <p>The concrete path to the right field bleachers has a running slope up to 7%.</p> <p>Resurface the estimated 200 sq ft surface area to create an accessible route not to exceed a 5% running slope and 2.08% cross slope.</p> <p>Reference: ADA 402 Photo: LanganBaseball-053 Record #: 195</p>	<p>Priority 2 - Serious</p>	<p>\$14,000</p>

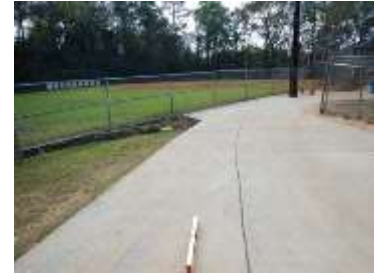
<p><u>Ball Field D</u></p>	<p>Modify existing pathway</p> <p>There is up to a 10% running slope on the concrete path leading from Ball Field C to Ball Field D.</p> <p>Resurface the estimated 20 ft of concrete path not to exceed 5% running slope and 2.08% cross slope.</p> <p>Reference: ADA 402 Photo: LanganBaseball-070 Record #: 198</p>	<p>Priority 2 - Serious</p>	<p>\$11,200</p>

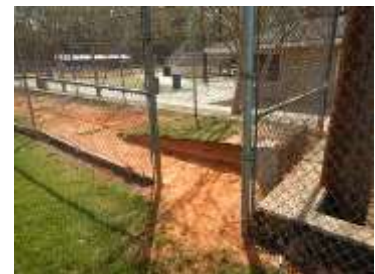
<p><u>Ball Field B -- Bull Pens</u></p>	<p>Provide accessible route to sports field/court</p> <p>The ramps at the both the right and left field bull pens reduce the clear width for entry to 30 inches.</p> <p>Remove the wood ramps and provide an accessible point of entry into each bull pen with a minimum 32 inch (preferably 36 inch) wide opening and connected to the accessible route of the existing concrete path.</p> <p>Reference: ADA 206, 221.2.1.4, 402 Photo: LanganBaseball-095 Record #: 206</p>	<p>Priority 2 - Serious</p>	<p>\$5,000</p>

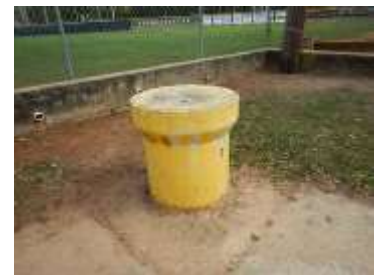
<p><u>Ball Field B</u></p>	<p>Add/replace existing drinking fountain with high-low unit</p> <p>There are a Mobile drinking fountains located at each of the team dugouts. Neither drinking fountain is accessible or located on an accessible route.</p> <p>Replace each drinking fountain with a new high-low combination unit in order to provide both a wheelchair accessible height fountain and a standing height fountain. Install on an accessible route positioned with clear floor space set back from the accessible route so not to obstruct pedestrian traffic.</p> <p>Reference: ADA 211, 602 Photo: LanganBaseball-091 Record #: 209</p>	<p>Priority 2 - Serious</p>	<p>\$6,000</p>

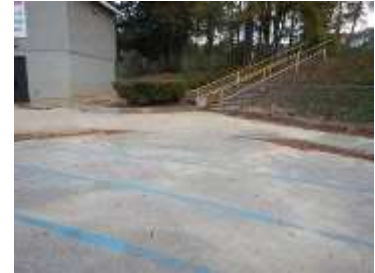
<p><u>East - Parking</u></p>	<p>Modify existing pathway</p>	<p>Priority 2 - Serious</p>	<p>\$2,500</p>
		<p>A raised non-compliant ramp projects from a corner of the parking lot.</p> <p>Evaluate the preferred pedestrian path from the site arrival point to the amenities of the east side of the baseball complex. Remove the raised ramp projecting into the parking lot and install blended transition curb cuts at the access aisles for the accessible parking spaces.</p> <p>Reference: ADA 402 Photo: LanganBaseball-117 Record #: 213</p>

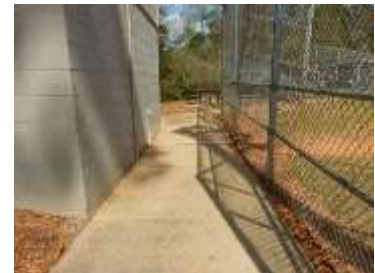
<p><u>Ball Field F</u></p>	<p>Correct changes in level/openings for accessible route</p>	<p>Priority 3 - Moderate</p>	<p>\$1,200</p>
		<p>There is PVC/conduit running across the width of the accessible route in front of the press/scorer building creating up to a 1 inch change in level. There are 2 light posts along the accessible route with changes in level up to 1 inch at the ground surface.</p> <p>Either bury the conduit or install a beveled surface treatment such as a rubber duct/cord cover with beveled edges not to exceed 1/2 inch. Install concrete or crusher fines around the 2 posts to eliminate the change in level.</p> <p>Reference: ADA 302.3, 303, 403.4 Photo: LanganBaseball-039 Record #: 190</p>

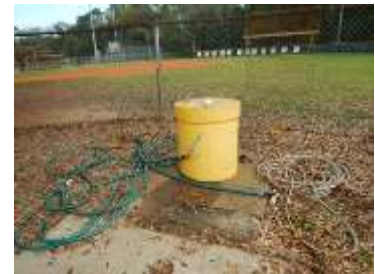
<p><u>Ball Field C</u></p>	<p>Add/replace existing drinking fountain with high-low unit</p>	<p>Priority 3 - Moderate</p>	<p>\$2,500</p>
		<p>There is a Mobile drinking fountain located along the right field fence. The drinking fountain is not wheelchair accessible.</p> <p>Replace the drinking fountain with a new high-low combination unit in order to provide both a wheelchair accessible height fountain and a standing height fountain. Install on an accessible route positioned with clear floor space set back from the accessible route so not to obstruct pedestrian traffic.</p> <p>Reference: ADA 211, 602 Photo: LanganBaseball-069 Record #: 199</p>

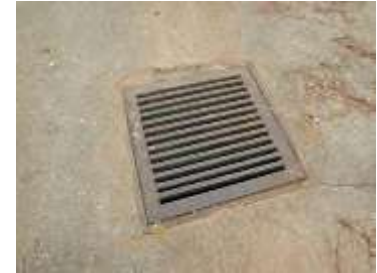
<p><u>Ball Field B</u></p>	<p>Replace grate(s) along accessible route</p> <p>There is a drain grate on the accessible route to the bleachers with openings up to 3/4 inch.</p> <p>Replace the 2 ft x 2 ft drain grate with a model having openings not to exceed 1/2 inch diameter.</p> <p>Reference: ADA 302.3 Photo: LanganBaseball-101 Record #: 208</p>	<p>Priority 3 - Moderate</p>	<p>\$500</p>

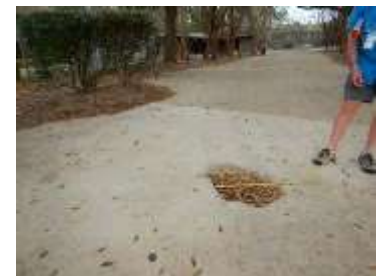
<p><u>Exterior Path Throughout Baseball Complex</u></p>	<p>Correct changes in level/openings for accessible route</p> <p>There are gaps, openings, changes in level, cracks and broken surface sections throughout the concrete exterior path at the baseball complex.</p> <p>Adopt a cyclical maintenance practice to monitor the path surface, gaps and changes in level, anticipating and scheduling segments for repair.</p> <p>Reference: ADA 302.3, 303, 403.4 Photo: LanganBaseball-047 Record #: 210</p>	<p>Priority 3 - Moderate</p>

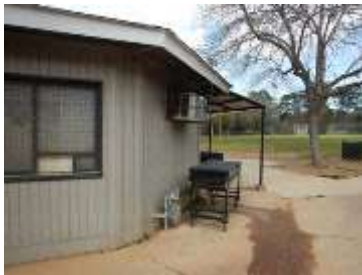
Exterior at Concession Building

There are 2 AC unit at the concession building that project into the pedestrian circulation path. This creates a safety hazard for people with visual impairments since they are not cane detectable.

Add panels to all 3 sides of each unit that extend to the ground surface to make the units cane detectable.

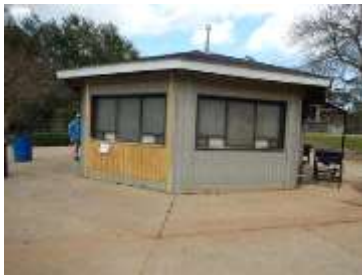
Exterior at Concession Building

The 2 concessions service counters are too high at 39 inches above the ground surface.

Lower a section of each sales counter for either a parallel or forward approach. For a parallel approach, the counter surface shall be 36 inches long minimum and 36 inches high maximum above the finish floor shall be provided. If this section of counter also serves as an employee work station, it is recommended the counter be lowered to an accessible work surface height 28 to 34 inches above the floor with knee clearance. The leading edge should not protrude more than 4 inches from the wall or side panels should be installed to make the counter cane detectable.

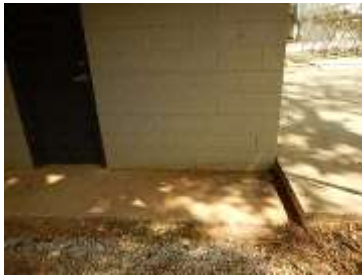
Exterior Route to Side Entrance

There is up to a 6 inch step along the concrete path to the employee entrance to the concession building.

Remove the 6 inch step, grade and resurface path to provide an accessible route to the concession building entrance.

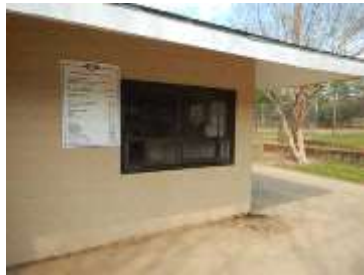
Exterior at Concessions Building

The service counter is too high at 37 1/2 inches above the floor.

Lower a section of the sales counter for either a parallel or forward approach. For a parallel approach, the counter surface shall be 36 inches long minimum and 36 inches high maximum above the finish floor shall be provided. If this section of counter also serves as an employee work station, it is recommended the counter be lowered to an accessible work surface height 28 to 34 inches above the floor with knee clearance. The leading edge should not protrude more than 4 inches from the wall or side panels should be installed to make the counter cane detectable.

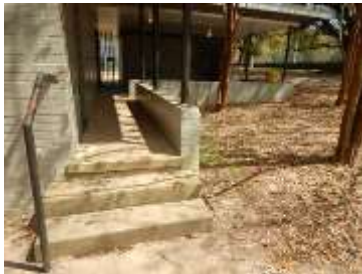
Exterior Path

There is no accessible route to the restroom building. There are 3 steps on the west entrance route and 1 step on the east entrance route.

Extend the accessible route to connect the main path to a main accessible point of entry to the restrooms. If the steps are to remain, install handrails on each side.

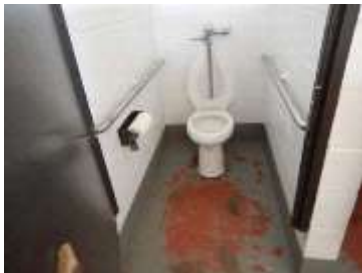
Men's and Women's Restrooms

There are no accessible restrooms serving the baseball complex. The existing restrooms lack accessible toilet compartments, lavatories and fixtures.

Renovate each restroom to provide a minimum of one accessible toilet compartment, lavatory, mirror, and paper towel dispenser. Install restroom identification signs.

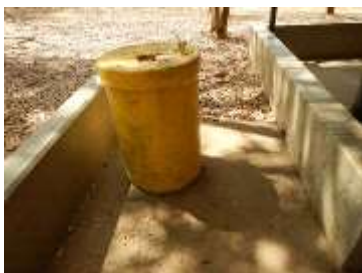
Exterior Common Area

There is a Mobile drinking fountain located in the exterior common area at the restroom building. The drinking fountain is not wheelchair accessible.

Replace the drinking fountain with a new high-low combination unit in order to provide both a wheelchair accessible height fountain and a standing height fountain. Install on an accessible route positioned with clear floor space set back from the accessible route so not to obstruct pedestrian traffic.

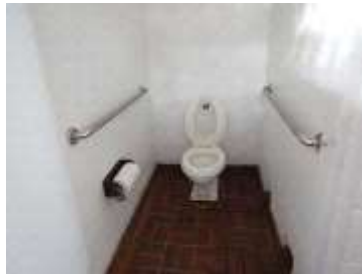
Men's and Women's Restrooms

There are no accessible restrooms serving this area of the baseball complex. The existing restrooms lack accessible toilet compartments, lavatories and fixtures.

Renovate each restroom to provide a minimum of one accessible toilet compartment, lavatory, mirror, and paper towel dispenser. Install restroom identification signs.
