# Langan Park

City of Mobile Parks and Recreation

Assessment Date: 3/18/2017  
 Accessibility Assessment Conditions Report

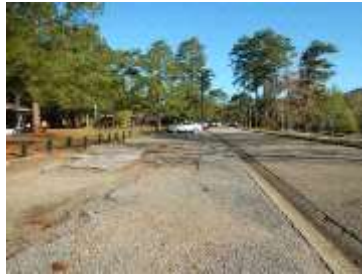
**Parking at Ludlow Circle Entrance Serving Shelters #1-3**

There are an estimated 40 standard parking spaces service picnic shelters #1-3. No spaces are striped or designated as accessible. The broken and heaved asphalt creates changes in level throughout the parking area.

**Grade, resurface and stripe existing parking lot to include accessible parking spaces and access aisles**

For this size parking lot, at least 2 accessible parking spaces are required. Grade, resurface and stripe for a minimum of 1 van accessible parking space (132 inches wide), 1 car accessible parking space (96 inches wide), and access aisles (60 inches wide). Alternatively, all accessible parking spaces could be striped as universal with 96 inch width for each accessible space and 96 inch width for each access aisle. Install signs designating the accessible parking spaces including the International Symbol of Accessibility. Signs identifying van parking spaces shall contain the designation "van accessible." Signs shall be 60 inches minimum above the finish floor or ground surface measured to the bottom of the sign.

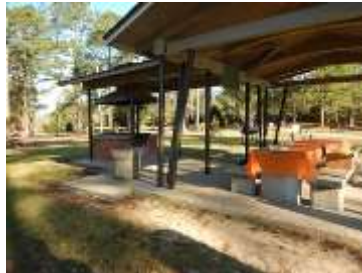
**Picnic Shelters #1-11**

There are 11 picnic shelters serving the park. There is no accessible route connecting the picnic shelters to the nearest available accessible parking. The picnic shelters are on concrete pads with 1-6 inch change in level from the ground surface to the concrete. None of the picnic shelters have accessible picnic tables, grills with accessible cooking surfaces or accessible drinking fountains.

**Provide picnic units with mobility features**

At least 20 percent, but not less than 3 of the 11 picnic units shall provide mobility features including accessible outdoor constructed features, location on an outdoor recreation access route, wheelchair seating, a minimum 36 inch clear floor space around usable sides and operating parts within the reach range. The priority 3 accessible picnic shelters should be dispersed; 1 in cluster #1-4; 1 at the playground nearest the accessible restroom either #7 or #8; and 1 at #9-10 along the waterfront. As other picnic shelters are repaired or renovated, they should also be made accessible.

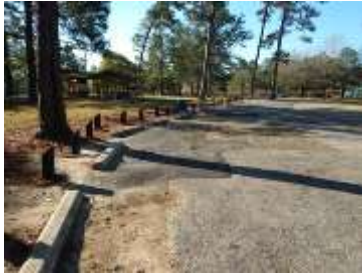
**Parking Serving Picnic Shelters #4-6**

There are an estimated 50 standard parking spaces service picnic shelters #4-6. No spaces are striped or designated as accessible. The broken and heaved asphalt creates changes in level throughout the parking area.

**Grade, resurface and stripe existing parking lot to include accessible parking spaces and access aisles**

For this size parking lot, at least 2 accessible parking spaces are required. Grade, resurface and stripe for a minimum of 1 van accessible parking space (132 inches wide), 1 car accessible parking space (96 inches wide), and access aisles (60 inches wide). Alternatively, all accessible parking spaces could be striped as universal with 96 inch width for each accessible space and 96 inch width for each access aisle. Install signs designating the accessible parking spaces including the International Symbol of Accessibility. Signs identifying van parking spaces shall contain the designation "van accessible." Signs shall be 60 inches minimum above the finish floor or ground surface measured to the bottom of the sign.

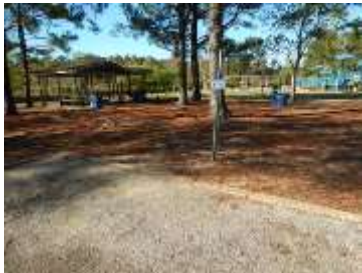
**Parking Serving Picnic Shelters #7-8**

There are an estimated 12 standard parking spaces service picnic shelters #7-8. No spaces are striped or designated as accessible.

**Grade, resurface and stripe existing parking lot to include accessible parking spaces and access aisles**

For this size parking lot, at least 1 accessible parking space is required. Grade, resurface and stripe for a minimum of 1 van accessible parking space (132 inches wide) and access aisles (60 inches wide). Alternatively, all accessible parking spaces could be striped as universal with 96 inch width for each accessible space and 96 inch width for each access aisle. Install signs designating the accessible parking spaces including the International Symbol of Accessibility. Signs identifying van parking spaces shall contain the designation "van accessible." Signs shall be 60 inches minimum above the finish floor or ground surface measured to the bottom of the sign.

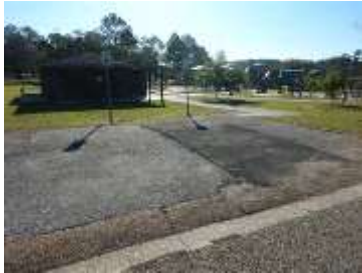
Parking Serving Picnic Shelter #11 and Restroom Building

There are an estimated 42 standard parking spaces. While 2 spaces are signed as the "accessible" parking spaces, there are no pavement markings for the spaces or access aisle. The accessible route is purposed to connect to the parking spaces. However the lack of a marked access aisle and surface in front of the accessible spaces can result in the accessible route being blocked by parked vehicles.

**Stripe accessible parking space and access aisle**

Stripe for a minimum of one van accessible parking space (132 inches wide), one car accessible parking space (96 inches wide) and access aisles (60 inches wide). Alternatively, all accessible parking spaces could be striped as universal with 96 inch width for each accessible space and 96 inch width for each access aisle. It may be necessary to extend the asphalt surface in front of the parking spaces to provide a clear path connecting to the accessible route.

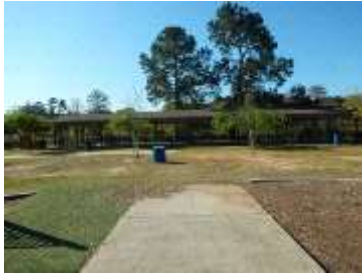
Picnic Shelters #9-10

Picnic shelters #9-10 are the closest in proximity to the main playground, the waterfront, and the restroom building. However, the main path stops short of connecting the shelters to the other park amenities by less than 50 ft. The path on the south side of the shelter connecting to the share use path has a running slope up to 13.4%. There are 6 standard wood picnic tables in the shelter and no accessible units. A built-in grill is provided at each end of the shelters, however the cooking surface is too high. The drinking fountain is mounted on a pad with a 2 inch change in level, lacks knee clearance and a height for a standing unit. There is a change in level to the water faucet and the operating control is not accessible.

**Provide picnic units with mobility features**

Modifications are recommended to be made to picnic shelters #9-10 first to more immediately achieve compliance with the "program access" standard. Extend the concrete path 50 ft from the playground a point of entrance for the picnic shelter. Resurface the existing path or install a new path to connect the south side of the picnic shelter to the main path along the waterfront. Replace at least 2 picnic tables with accessible units providing wheelchair seating and a minimum 36 inch clear floor space around usable sides. Convert one of the built-in grills to provide a fire building surface 9 inches minimum from the ground, a cooking surface 15 to 34 inches maximum from the ground, and 48 x 48 inch clear ground space on all usable sides. Replace the drinking fountain with a high-low unit and correct the change in level on the approaching concrete pad. Replace the water faucet with an accessible operating control and accessible clear floor space in front of the unit.

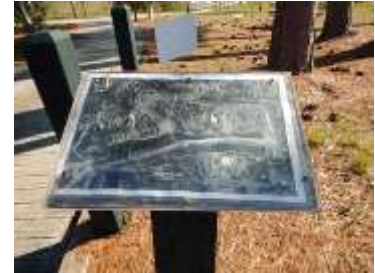
<p><u>Parking at South End of Ludlow Circle</u></p>	<p><b>Provide trailhead signage with accessibility information</b></p>	<p>Priority 1 - Critical</p>	<p>\$4,000</p>
		<p>A trail sign aerial map is provided at the parking lot trailhead for the multi-use shared path. The graphic lacks contrast and wayfinding information for people with visual impairments or developmental disabilities. The wayside is mounted in the ground surface beyond the concrete curb and outside of the viewing distance for someone seated in a wheelchair.</p>		
		<p>Provide visitor information on trailhead signage including the length of the trail or trail segment; surface type; average and minimum tread width; average and maximum running slope; and average and maximum cross slope. Install a level surface at the approach to the sign, a minimum 30 x 48 inches, or relocate the sign to within viewing of the path with a 30 x 48 inch clear floor space.</p>

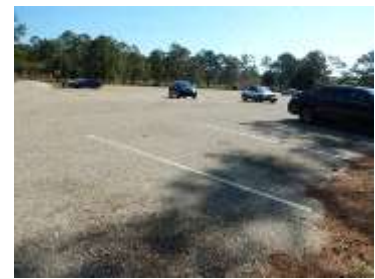
<p><u>Large Parking Lot for Jimmie Morris Performing Arts Pavilion on Flournoy Dr</u></p>	<p><b>Grade, resurface and stripe existing parking lot to include accessible parking spaces and access aisles</b></p>	<p>Priority 1 - Critical</p>	<p>\$5,200</p>
		<p>There are an estimated 200 standard parking spaces for the large parking lot serving the performing arts pavilion. None of the parking spaces are designated as accessible.</p>		
		<p>For this size parking lot, at least 6 accessible parking spaces are required. Stripe for a minimum of one van accessible parking space (132 inches wide), 4 car accessible parking space (96 inches wide) and access aisles (60 inches wide). Alternatively, all accessible parking spaces could be striped as universal with 96 inch width for each accessible space and 96 inch width for each access aisle. Install signs designating the accessible parking spaces including the International Symbol of Accessibility. Signs identifying van parking spaces shall contain the designation "van accessible." Signs shall be 60 inches minimum above the finish floor or ground surface measured to the bottom of the sign.</p>

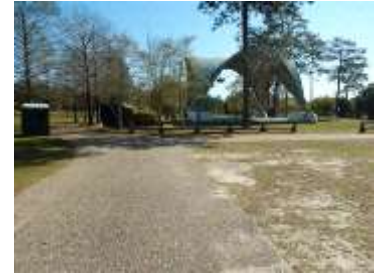
<p><u>Jimmie Morris Performing Arts Pavilion</u></p>	<p><b>Modify existing pathway</b></p> <p>There is no accessible route from the parking lot to the performing arts pavilion.</p> <p>Install a pedestrian crossing and accessible route connecting the pavilion to accessible parking in the large parking lot.</p> <p>Reference: ADA 402                      Photo: LanganPark-121                      Record #: 157</p>	<p>Priority 1 - Critical</p>	<p>\$35,000</p>

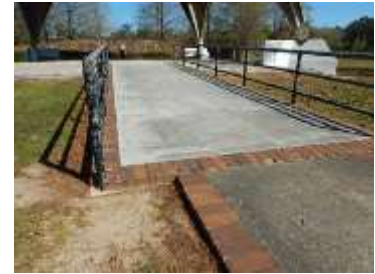
<p><u>Jimmie Morris Performing Arts Pavilion</u></p>	<p><b>Correct changes in level/openings for accessible route</b></p> <p>The ramp from the pavilion narrows at the path creating up to a 3 inch change in level. This could also be considered a tripping hazard at night or in larger crowds walking to/from the pavilion.</p> <p>Widen the path by 12 inches on each side to eliminate the drop-off/tripping hazard. Or install alternative edge protection such as guard railing or curb.</p> <p>Reference: ADA 302.3, 303, 403.4                      Photo: LanganPark-125                      Record #: 158</p>	<p>Priority 1 - Critical</p>	<p>\$4,000</p>

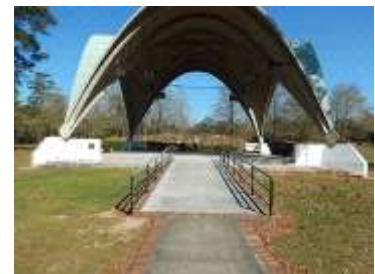
<p><u>Jimmie Morris Performing Arts Pavilion</u></p>	<p><b>Provide a portable assistive listening system and install corresponding signage</b></p> <p>Public presentations and performances are made at the performing arts pavilion. No assistive listening system is available.</p> <p>Acquire a portable assistive listening system for the outdoor amphitheater. Install the required signage and make information on its availability known to visitors.</p> <p>Reference: ADA Effective Communication 35.160, ADA 219                      Photo: LanganPark-122                      Record #: 159</p>	<p>Priority 1 - Critical</p>	<p>\$2,600</p>

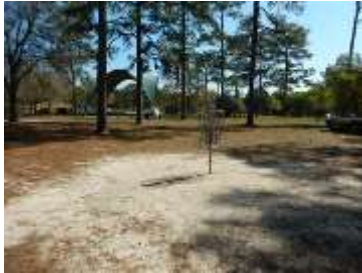
Disc Golf Course & Open Picnic Area

There is a 6 inch curb and no accessible route from the parking lot or street parking to the first tee for the disc golf course or the open picnic/sitting area near the first tee.

**Modify existing pathway**

Construct an accessible route linking the first tee for the disc golf course, the open picnic/sitting area and the accessible parking.

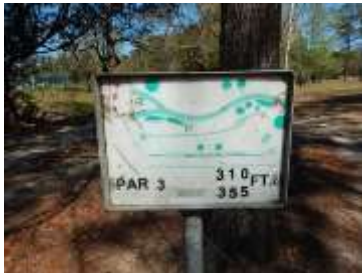
Disc Golf Course

The disc golf course lacks consistent informational and wayfinding signage at the first tee and throughout the course. The graphics and text may be considered too small for the viewing distances.

**Provide access to disc golf course**

Consider a comprehensive design for the placement of all tees and holes/baskets. Install an accessible route connecting the site arrival point to the first tee of the disc golf course. Provide visitor information on disc golf course trailhead signage including the length of each hole; surface type; average and minimum tread width; average and maximum running slope; and average and maximum cross slope. Consider providing redundant signage at different points of the disc golf course for wayfinding. Provide visitor information on disc golf course trailhead signage including the length of each hole; surface type; average and minimum tread width; average and maximum running slope; and average and maximum cross slope. Consider providing redundant signage at different points of the disc golf course for wayfinding.

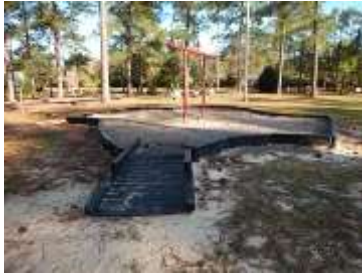
Play Area at Picnic Shelter #1

There are 3 play areas contained by plastic molded borders at picnic shelter #1. There is no accessible route connecting the play area to the site arrival point/parking and other park amenities. The plastic molded ramps into each play area have a running slope up to 8% and a 3-4 inch change in level into the engineered wood fiber play surface. There is up to an 8.8% ramp up to the perimeter and an 8 inch change in level due to the settling of the engineered wood fiber playground surface. The undulation of the surface material exceeds the maximum allowable 6.25% slope for the accessible route to play components and the maximum allowable 2.08% clear floor space at play components.

**Modify accessible route to playground/play components**

Install an accessible route connecting the play area to the site arrival point/parking and other park amenities. Rake the engineered wood fiber level, replenish the surface material as necessary and compact the surface system to eliminate the undulation. Refer to the manufacturer's recommendations for installation and maintenance to ensure a level, accessible play surface not to exceed 6.25% for the accessible route and 2% in the clear floor spaces for accessible play components.

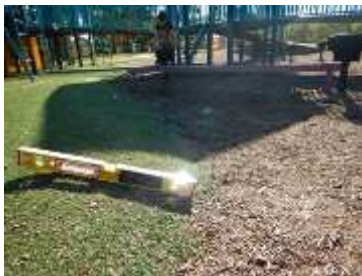
Large Playground at Picnic Shelter #7-8

The playground is surfaced with artificial turfgrass and engineered wood fiber. Several of the points of egress for play components are in the area surfaced with engineered wood fiber. Lack of maintenance of the loose fill surface has resulted in a change in level up to 7 inches and a running slope up to 28%. The undulation of the surface material exceeds the maximum allowable 6.25% slope for the accessible route to play components and the maximum allowable 2.08% clear floor space at play components.

**Provide accessible play surface**

Rake the engineered wood fiber level, replenish the surface material as necessary and compact the surface system to eliminate the undulation. Refer to the manufacturer's recommendations for installation and maintenance to ensure a level, accessible play surface not to exceed 6.25% for the accessible route and 2% in the clear floor spaces for accessible play components. The engineered wood fiber should be replenished and compacted to a level to provide a smooth transition from the artificial turfgrass.

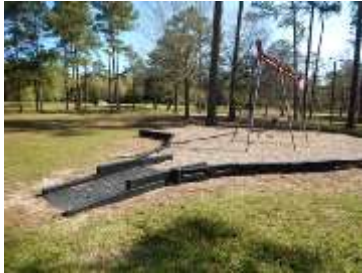
Play Area at Ludlow Circle Exit, North of Restroom Building

There are 3 play areas with swings contained by plastic molded borders north of the restroom building and main playground. There is no accessible route connecting the play area to the site arrival point/parking and other park amenities. The plastic molded ramps into each play area have a running slope up to 8% and a 3-4 inch change in level into the engineered wood fiber play surface. The undulation of the surface material exceeds the maximum allowable 6.25% slope for the accessible route to play components and the maximum allowable 2.08% clear floor space at play components.

**Modify accessible route to playground/play components**

Install an accessible route connecting the play area to the site arrival point/parking and other park amenities. Rake the engineered wood fiber level, replenish the surface material as necessary and compact the surface system to eliminate the undulation. Refer to the manufacturer's recommendations for installation and maintenance to ensure a level, accessible play surface not to exceed 6.25% for the accessible route and 2% in the clear floor spaces for accessible play components.

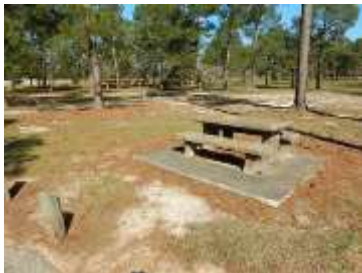
Open Picnic Area North of Restroom Building

There are 8 picnic tables mounted on concrete pads in the open space. There is no accessible route connecting the picnic tables to the site arrival point/parking and other park amenities.

**Provide picnic units with mobility features**

Provide an accessible route to connect to the accessible picnic units, to include clear floor space around all usable sides to the accessible picnic tables. At least 20 percent, but not less than two, of the picnic units shall provide mobility features including accessible outdoor constructed features, location on an outdoor recreation access route, wheelchair seating, a minimum 36 inch clear floor space around usable sides and operating parts within the reach range. Replace the existing picnic tables with accessible models, select units with a minimum 27 inch knee clearance under the table for a depth of a minimum 17 inches.

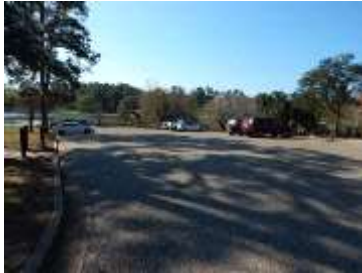
Parking at South End of Ludlow Circle

There are an estimated 28 standard parking spaces in the parking lot south of Ludlow Circle serving the multi-use path for the park. None of the parking spaces are designated as accessible.

**Grade, resurface and stripe existing parking lot to include accessible parking spaces and access aisles**

For this size parking lot, at least 2 accessible parking spaces are required. Stripe for a minimum of one van accessible parking space (132 inches wide), one car accessible parking space (96 inches wide) and access aisles (60 inches wide). Alternatively, all accessible parking spaces could be striped as universal with 96 inch width for each accessible space and 96 inch width for each access aisle. Install signs designating the accessible parking spaces including the International Symbol of Accessibility. Signs identifying van parking spaces shall contain the designation “van accessible.” Signs shall be 60 inches minimum above the finish floor or ground surface measured to the bottom of the sign.

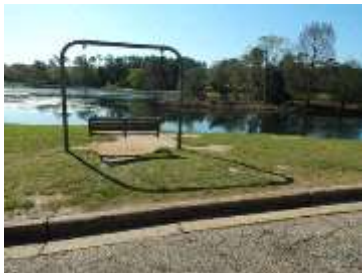
Bench Swing Near Parking at South End of Ludlow Circle

There is a bench overlooking the waterfront that has been modified into a swinging bench. The modifications do not meet the ASTM standards for swings including seat height, arm rest, clearance from the support posts, and likely swing impact. The grass surface does not meet the ASTM requirements for impact attenuation.

**Schedule the playground equipment and surface for replacement**

Remove the bench swing. The design and installation of these bench swings is not recommended for public parks. If this experience is deemed a priority for the site, consult with a commercial playground or park equipment supplier to select a durable, accessible model. The unit is recommended to be installed on an accessible route with clear floor space for wheelchair transfer and accessible, protective surfacing for the use zone, similar to the requirements for playgrounds.

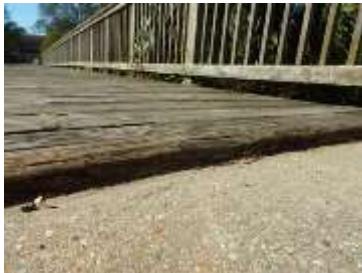
<p><u>Multi-Use Path</u>  <b>Correct changes in level/openings for accessible route</b></p> <p>There is up to a 2 inch change in level at the transitions from the concrete path to the boardwalk bridge on the multi-use path.</p> <p>Install a beveled transition plate or alternate means to provide a smooth transition between the two surfaces. Changes in level between ¼ inch high minimum and ½ inch high maximum shall be beveled with a slope not steeper than 1:2.</p> <p>Reference: ADA 302.3, 303, 403.4                      Photo: LanganPark-105                      Record #: 155</p>	<p>Priority 2 -                      Serious</p>	<p>\$1,000</p>

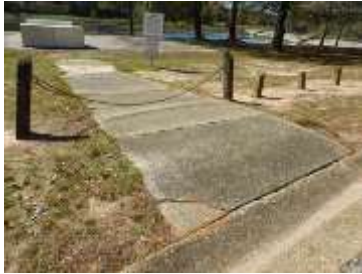
<p><u>Skate park/ramp</u>  <b>Modify existing pathway</b></p> <p>A skate park/ramp feature has been installed south of the performing arts pavilion. There is no accessible route connecting the skate park/ramp feature with the parking lot. There is a 6 inch curb at the concrete sidewalk and a running slope up to 13%.</p> <p>Remove the existing 30 ft section of sidewalk, grade, install a curb cut and pave the sidewalk with a running slope not to exceed 5%.</p> <p>Reference: ADA 402                      Photo: LanganPark-128                      Record #: 162</p>	<p>Priority 2 -                      Serious</p>	<p>\$15,000</p>

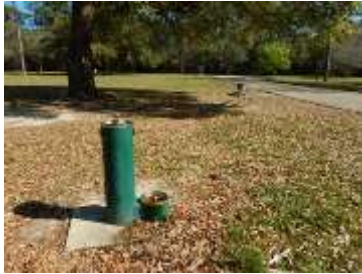
<p><u>Jimmie Morris Performing Arts Pavilion</u>  <b>Add/replace existing drinking fountain with high-low unit</b></p> <p>The drinking fountain off the path to the pavilion is not wheelchair accessible or located on an accessible route.</p> <p>Extend the existing path to provide an accessible route and clear floor space for the drinking fountain. Replace the drinking fountain with a new high-low combination unit in order to provide both a wheelchair accessible height fountain and a standing height fountain.</p> <p>Reference: ADA 211, 602                      Photo: LanganPark-119                      Record #: 160</p>	<p>Priority 3 -                      Moderate</p>	<p>\$5,500</p>

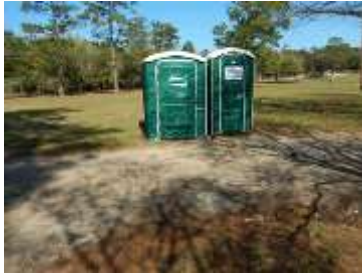
Jimmie Morris Performing Arts Pavilion

Portalets, one standard and one wheelchair accessible, are located adjacent to the path behind the pavilion. While the units can be considered to be located on an accessible route, there is up to 1/2 inch change in level between the path surface and the floor surface for the portalets.

**Correct changes in level/openings for accessible route**

Install a beveled molded plastic transition plate or alternate means to provide a smooth transition between the two surfaces. Changes in level between ¼ inch high minimum and ½ inch high maximum shall be beveled with a slope not steeper than 1:2.

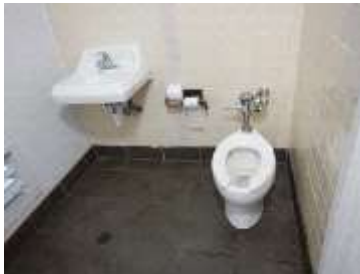
Men's and Women's Restroom

There is no accessible route connecting the concession/restroom building. There is up to a 6 inch change in level to the concrete pad. Neither restroom has an accessible toilet compartment. The restrooms lack tactile room identification signs. The door locks are out of the reach range and require tight grasping and twisting. The toilet stalls lack clear floor space and grab bars. There is no accessible route to the "accessible" restroom building at picnic shelters #7-8.

**Construct family/single user restroom**

As an interim solution, install directional signage to the "accessible" restroom building at picnic shelter #7-8. Also consider the installation of an accessible portalet. Retrofit each restroom to a single user accessible restroom; install tactile room identification signs on the adjacent latch side of each door; replace the door hardware with lever handles and accessible locks; reconfigure the fixtures for clear floor space and turning space; install grab bars; install accessible lavatories with insulated pipes; install soap and paper towel dispensers within the reach range.

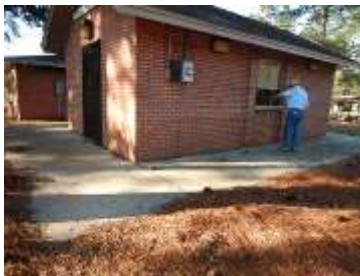
Concessions

There is no accessible route to the service counter at the concession/restroom building. There is up to a 6 inch change in level from the ground surface to the concrete pad. The service counter is too high at 41 inches above the ground surface.

**Lower section of sales/service counter**

Install an accessible route connecting the concession service counter to the site arrival point and accessible parking spaces to be installed. Lower a section of the sales counter for either a parallel or forward approach. For a parallel approach, the counter surface shall be 36 inches long minimum and 36 inches high maximum above the finish floor shall be provided. If this section of counter also serves as an employee work station, it is recommended the counter be lowered to an accessible work surface height 28 to 34 inches above the floor with knee clearance.

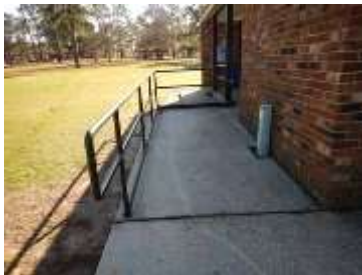
Men's Restroom

There are gaps greater than 1/2 inch at the joints on the concrete ramp to the men's restroom. A utility box projects from the side of the building along the ramp where the edge of the concrete had up to a 4 inch change in level, creating a tripping/tipping hazard.

**Modify existing pathway**

Fill the joints along the concrete ramp so gaps do not exceed 1/2 inch openings. Apply surface treatment surrounding the utility box to eliminate the change in level on the ground surface.

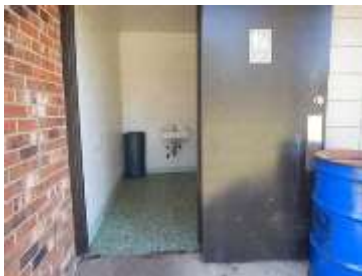
Men's Restroom

The opening force for the exterior door is 9 lbs.

**Adjust door opening force and/or evaluate for installation of automatic/power-assisted door system**

Adjust the closers on the exterior doors to reduce the opening force to as close to 5-8 lbs as possible. If this is not practical, the entity should evaluate this entrance for the installation of an automatic or power assisted door system.

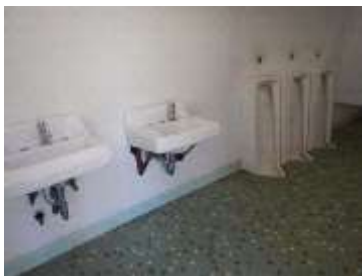
Men's Restroom

The lavatory pipes are exposed.

**Insulate exposed pipes at lavatory**

Insulate the exposed pipes at the lavatory to protect from burn or abrasion.

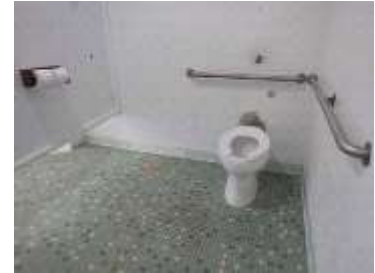
<p><u>Men's Restroom</u></p>	<p><b>Raise/lower toilet paper dispenser</b></p> <p>The toilet paper dispenser in the accessible stall is located on the far side of the stall outside of the reach range.</p> <p>Relocate the toilet paper dispenser to the side wall adjacent to the toilet. The outlet of the toilet paper dispenser shall be mounted within the reach range, 15-48 inches above the floor. The centerline of the dispenser shall be mounted 7-9 inches in front of the water closet. The space between the grab bar and projecting objects below and at the ends shall be 1½ inches minimum. The space between the grab bar and projecting objects above shall be 12 inches minimum.</p> <p>Reference: ADA 604.7, 609.3                      Photo: LanganPark-064                      Record #: 169</p>	<p>Priority 2 -                      Serious</p>	<p>\$50</p>

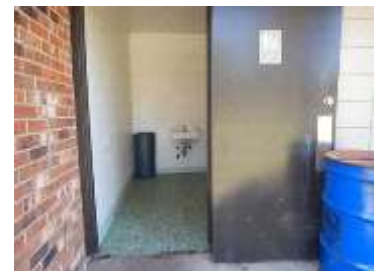
<p><u>Men's Restroom</u></p>	<p><b>Install/remount restroom identification signage with braille and raised characters</b></p> <p>The restroom identification sign is mounted on the door.</p> <p>Install new signage or relocate the existing restroom identification sign to the wall adjacent to the latch side of the door. Tactile characters on signs shall be located 48 inches minimum above the finish floor or ground surface, measured from the baseline of the lowest tactile character and 60 inches maximum above the finish floor or ground surface, measured from the baseline of the highest tactile character.</p> <p>Reference: ADA 703                      Photo: LanganPark-061                      Record #: 166</p>	<p>Priority 3 -                      Moderate</p>	<p>\$40</p>

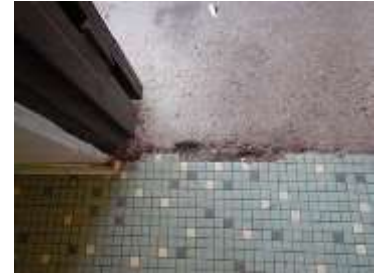
<p><u>Men's Restrooms</u></p> <p><b>Correct changes in level/openings for accessible route</b></p> <p>Missing and broken tiles at the door threshold result in a change in level greater than 1/4 inch.</p> <p>Replace the missing and broken tiles to create a smooth transition at the threshold not to exceed a change in level greater than 1/4 inch or 1/2 inch beveled.</p> <p>Reference: ADA 302.3, 303, 403.4                      Photo: LanganPark-065                      Record #: 170</p>	<p>Priority 3 - Moderate</p>	<p>\$250</p>

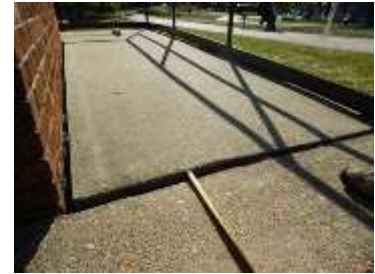
<p><u>Women's Restroom</u></p> <p><b>Correct changes in level/openings for accessible route</b></p> <p>There are gaps greater than 1/2 inch at the joints on the concrete ramp to the women's restroom.</p> <p>Fill the joints along the concrete ramp so gaps do not exceed 1/2 inch openings.</p> <p>Reference: ADA 302.3, 303, 403.4                      Photo: LanganPark-052                      Record #: 171</p>	<p>Priority 3 - Moderate</p>	<p>\$250</p>

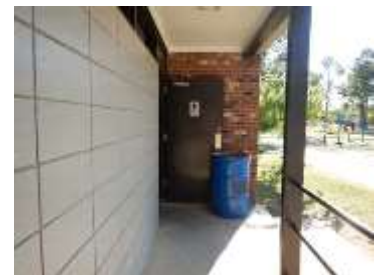
<p><u>Women's Restroom</u></p> <p><b>Install/remount restroom identification signage with braille and raised characters</b></p> <p>The restroom identification sign is mounted on the door.</p> <p>Install new signage or relocate the existing restroom identification sign to the wall adjacent to the latch side of the door. Tactile characters on signs shall be located 48 inches minimum above the finish floor or ground surface, measured from the baseline of the lowest tactile character and 60 inches maximum above the finish floor or ground surface, measured from the baseline of the highest tactile character.</p> <p>Reference: ADA 703                      Photo: LanganPark-053                      Record #: 172</p>	<p>Priority 3 - Moderate</p>	<p>\$40</p>

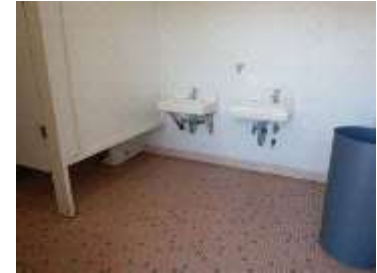
<p><u>Women's Restroom</u></p>	<p><b>Raise/lower lavatory</b></p> <p>The lavatory is mounted too low reducing the knee clearance to less than 26 inches above the finish floor. The lavatory pipes are exposed.</p> <p>Raise the lavatory and install with the front of the higher of the rim or counter surface 34 inches maximum above the finished floor and knee clearance 27 inches minimum above the finished floor. Insulate the exposed pipes at the lavatory to protect from burn or abrasion.</p> <p>Reference: ADA 606.3                      Photo: LanganPark-054                      Record #: 174</p>	<p>Priority 3 - Moderate</p>	<p>\$1,860</p>
	<p><u>Women's Restroom</u></p>	<p><b>Replace toilet stall door locking mechanism</b></p> <p>The accessible toilet stall lacks a latch.</p> <p>Replace the toilet stall door locking mechanism with accessible hardware. Operable parts shall be operable with one hand and shall not require tight grasping, pinching, or twisting of the wrist. The force required to activate operable parts shall be 5 lbs maximum. Door hardware shall be installed 34-48 inches above the finished floor.</p> <p>Reference: ADA 309                      Photo:                      Record #: 175</p>	<p>Priority 3 - Moderate</p>	<p>\$50</p>

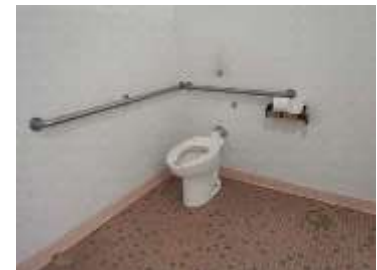
<p><u>Women's Restroom</u></p>	<p><b>Raise/lower toilet paper dispenser</b></p> <p>The toilet paper dispenser in the accessible stall is located on the back wall outside of the reach range.</p> <p>Relocate the toilet paper dispenser to the side wall adjacent to the toilet. The outlet of the toilet paper dispenser shall be mounted within the reach range, 15-48 inches above the floor. The centerline of the dispenser shall be mounted 7-9 inches in front of the water closet. The space between the grab bar and projecting objects below and at the ends shall be 1½ inches minimum. The space between the grab bar and projecting objects above shall be 12 inches minimum.</p> <p>Reference: ADA 604.7, 609.3                      Photo: LanganPark-055                      Record #: 176</p>	<p>Priority 3 - Moderate</p>	<p>\$50</p>

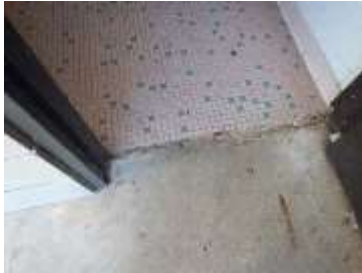
Women's Restroom

Missing and broken tiles at the door threshold result in a change in level greater than 1/4 inch.

**Correct changes in level/openings for accessible route**

Replace the missing and broken tiles to create a smooth transition at the threshold not to exceed a change in level greater than 1/4 inch or 1/2 inch beveled.
